Manhole Inspection Summary

Manhole # S21GG_031MH

Insp Date: **6/15/07 11:09 AM**

Location Address: **1607 FULTON AVE**

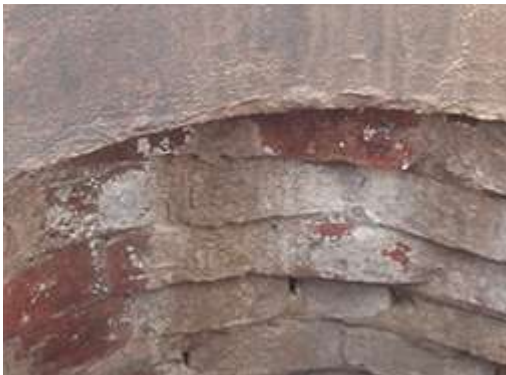
Defect 4

Infiltration: ☐ None ☒ **Joint** ☐ Cracks ☐ Mortar ☐ Roots ☐ Wall

INFILTRATION OF CHIMNEY

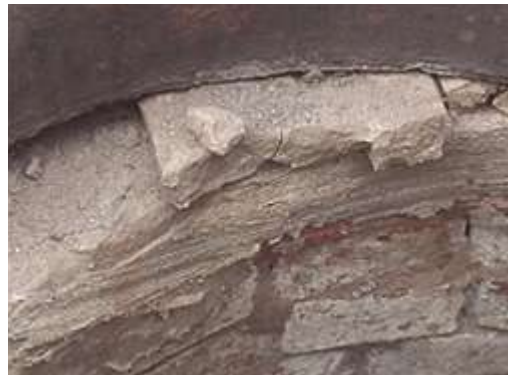
Defect 3

Condition: ☐ Sound ☐ Cracked ☐ Root Intrusion ☐ Loose Brick ☒ **Deteriorated**

CHIMNEY DETERIORATION

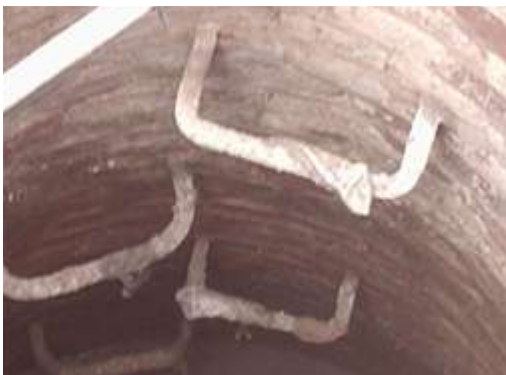
Defect 2

Surcharge ☒ **Evidence Of Surcharge** Depth: **4** (ft.) ☐ Active Surcharge Present

SURCHARGE EVIDENCE ON STEPS

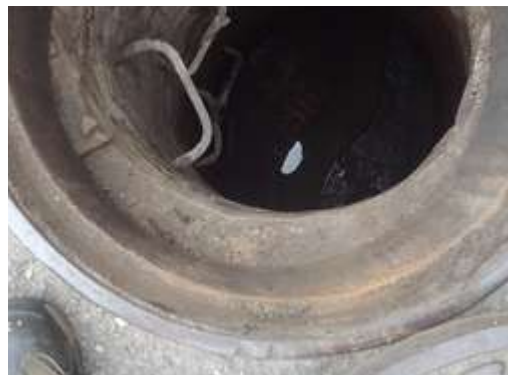
Defect 1

Frame Offset: **3** (in.) Condition: ☒ Sound ☐ Cracked ☐ Leaks

FRAME OFFSET

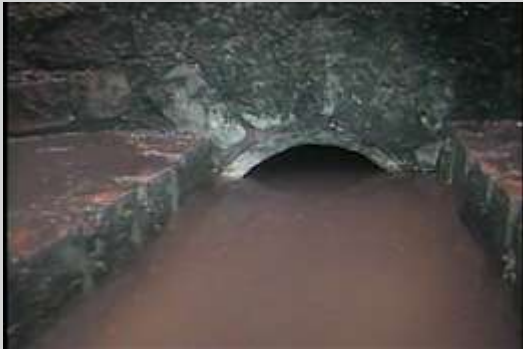
12 O'Clock Outflow

Comments **MANHOLE IS BACKING UP AND FLOWING IN THE REVERSE DIRECTION, CHANNEL HAS AN "S" SHAPE TO IT.**

FLOW IS REVERSED DUE TO DIRTY MH
